Willoughby Flood Action Plan - Part 2

April 2026

Appendix A. Oxford Canal flooding

CANAL FLOODING (WILLOUGHBY)

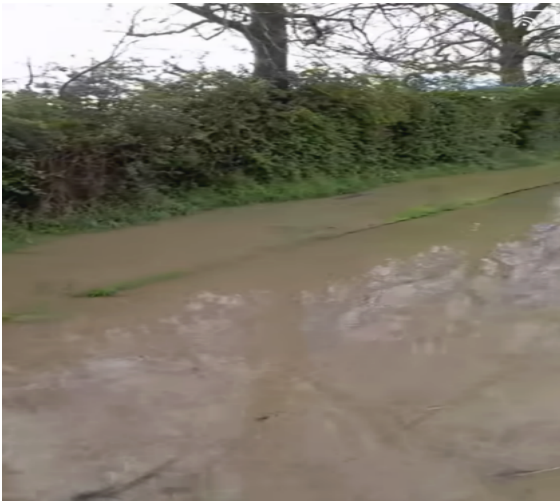
Photo 1:- Canal overtopping at Bridge 88

At times of sustained rainfall or severe thunderstorms the canal water level rises, flooding the towpath and overflowing the canal boundary into the fields beyond. Which is what occurred on May 9th 2023 when as result of a severe thunderstorm over the Braunston Catchment and North Daventry substantial quantities of water entered the canal resulting in overtopping in the length of canal around Bridge 88. (See photograph 1). Water cascaded into the adjacent fields.

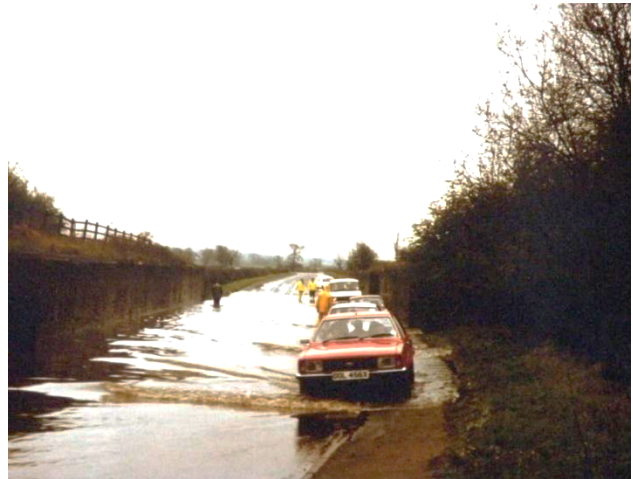
Photo 2:- A45 Flooded by Canal water off fields to East of Road (Old Station Bridge)

All the floodwater cannot pass through the two culverts and the surplus spreads across the adjacent fields. Because the A45 is higher than the surrounding fields the water accumulates and flows back towards the old Great Central Railway station. (The Turnpike was raised to avoid boggy ground when the road was built in the 1700's). When the GCR was built the roadway below the bridge was lowered to

provide extra clearance allowing the floodwater to build up on the roadway and flow diagonally across the road to bring floods into the village of Willoughby. (See photograph 2)

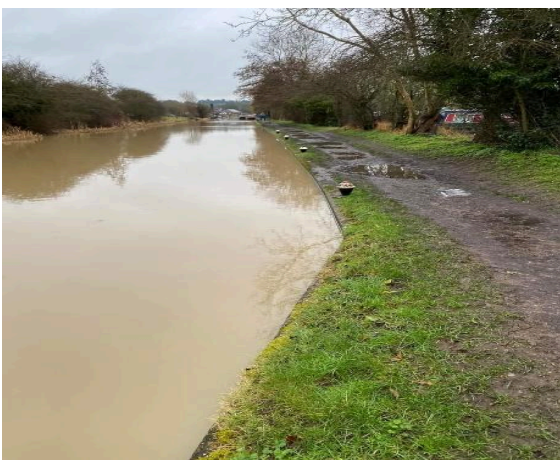
Photo 3 :- Oxford Canal topping banks towards Flecknoe

On February 18th 2024 the Willoughby Brook level rose early morning around 5am and was over road in lower Main Street by 7.30am. It was short lived and the level was falling by 8.45am. An early morning observer reported seeing fields flooded adjacent to canal overflow drain at A45 and another walker reported still high flow in Willoughby Brook under A45 later in day and queried if this might be due to canal overtopping. The canal was described as excessively high on social media and photographs of the canal overtopping the towpath towards Flecknoe are shown (Photograph 3). Comments by canal related people in criticism of design of Puddle Bank waste weir which is clearly inadequate to handle flows required to maintain the Oxford Canal within its banks. If the Affinity Project goes ahead this is an aspect of canal design which must be addressed.

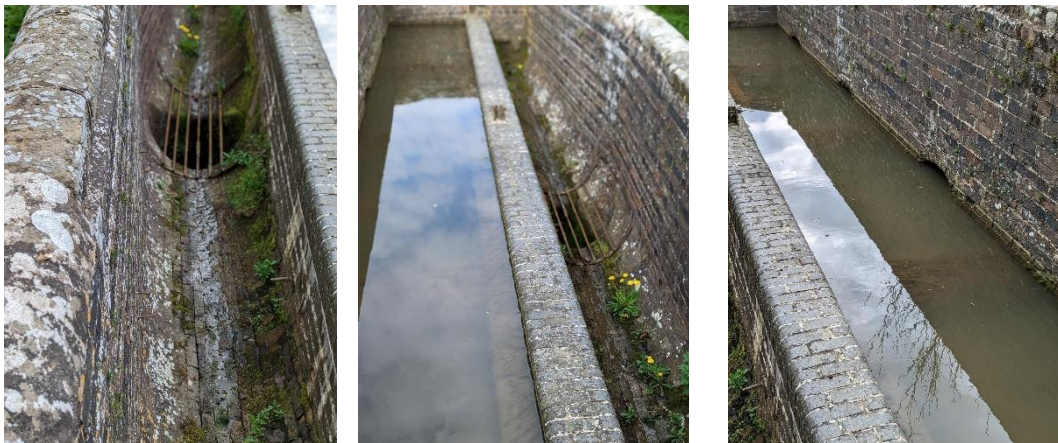
Puddle Bank Waste Weir Design

The Puddle Bank Weir is a vintage design introduced well before modern sluice and gate barriers were introduced. Four culverts are capable of passing water from the canal to a chamber some 25 feet long. The water is held back by a weir wall which presents a barrier to the water in the canal and when the water is level with the lip of this weir represents normal canal level. As the canal level rises during a flood the water level rises above the lip of the weir and the run-off is proportional to the depth of water above the weir lip. The water flow is limited by the quantity of water that the culverts can pass.

With the inevitable increase in rainfall resulting from climate change this facility, which is already unfit for purpose, will need to be replaced with a modern sluice gate with a three term control facility which maintains the level in the presence of increasing flow of water into the canal. The size of the overflow is insufficient to meet future needs and the use of a single major overflow is questionable. A distributed approach to overflow is probably required. A much more sophisticated technique will be required if the Affinity Water Project goes ahead.

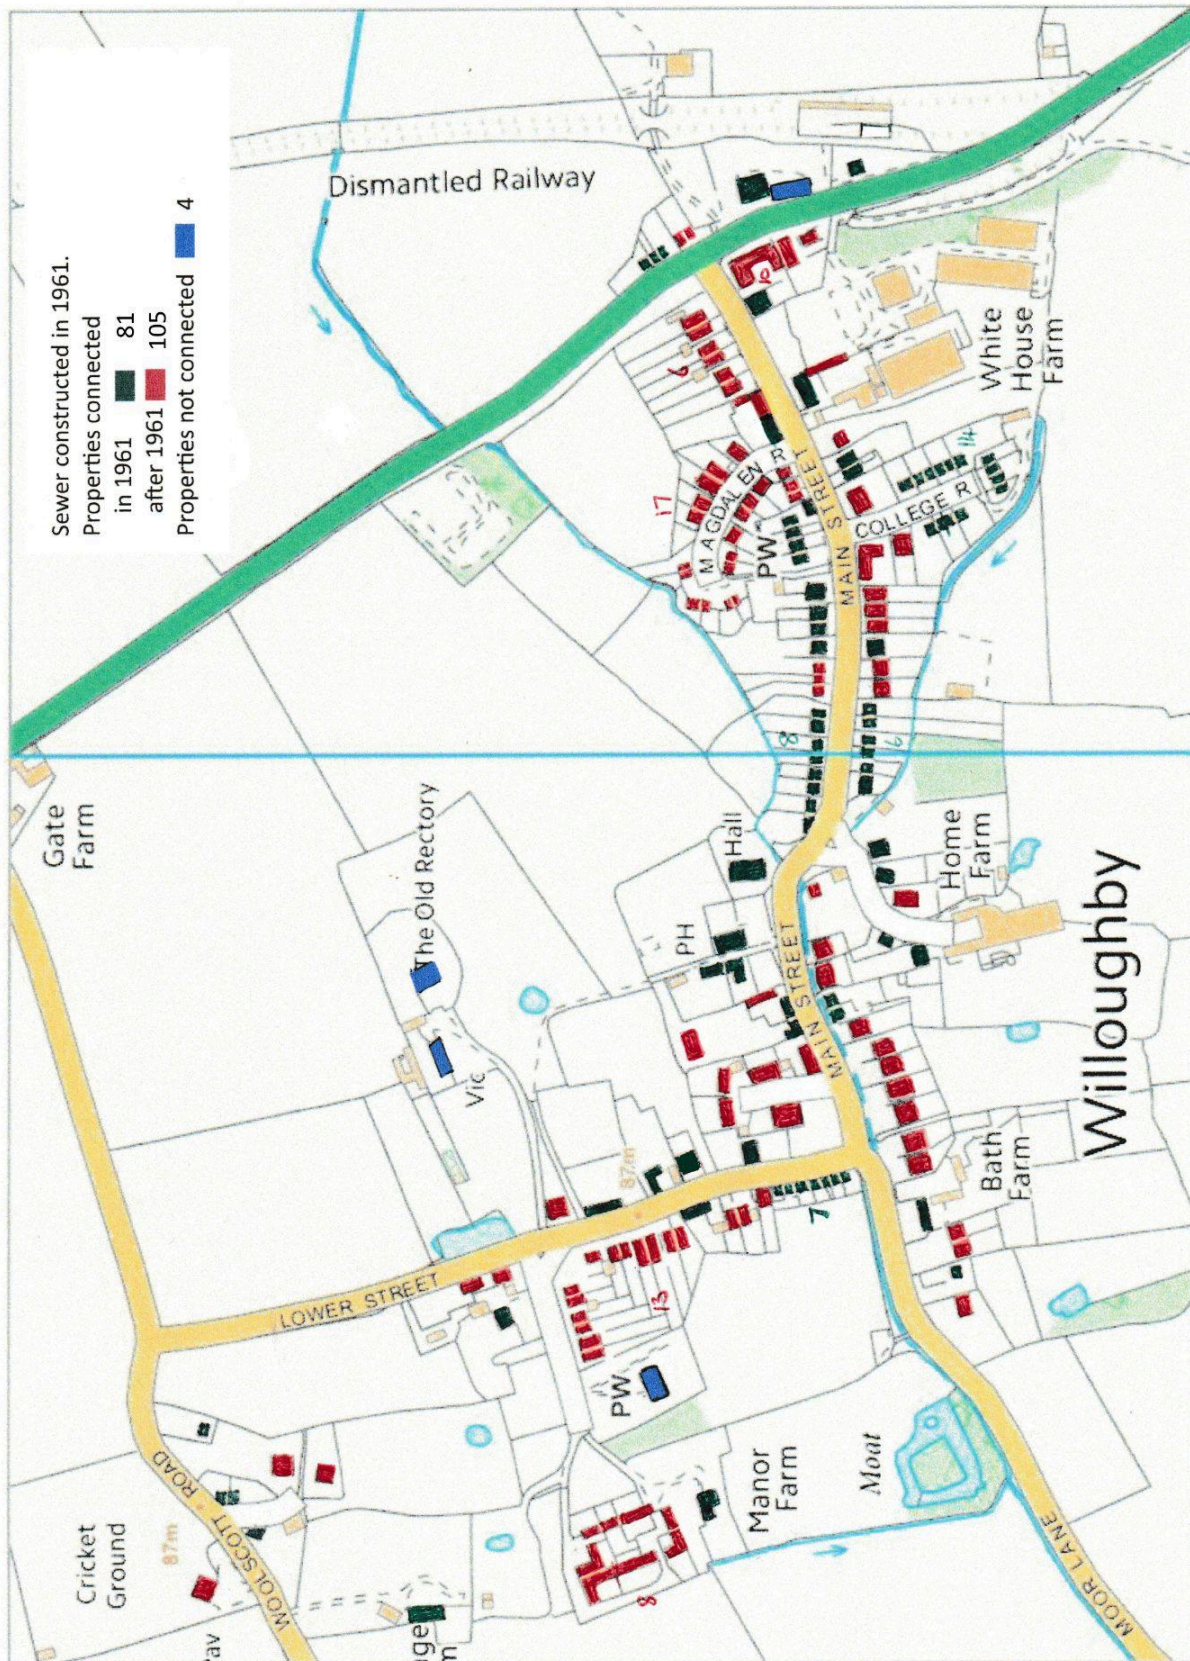
Appendix B. Sewerage System - Properties built before and after 1961

The main sewer in the village was constructed in 1961. A plan has been produced showing the number of properties that existed in 1961 (81) and the number built afterwards (105). The sewer is a combined sewer into which most properties discharge both sewage and rainwater. This leads to overloading of the sewer during periods of sustained rainfall and the lifting of inspection chamber covers so that sewage overflows into floodwater creating a significant environmental and health hazard.
