# **Willoughby Flood Action Plan - Part 2**

**July 2026**

## Appendix A. Oxford Canal flooding

### CANAL FLOODING (WILLOUGHBY)

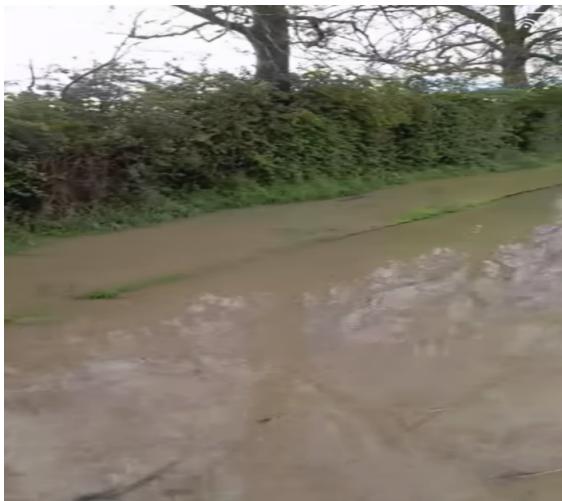
Photo 1:- Canal overtopping at Bridge 88

At times of sustained rainfall or severe thunderstorms the canal water level rises, flooding the towpath and overflowing the canal boundary into the fields beyond. Which is what occurred on May 9<sup>th</sup> 2023 when as result of a severe thunderstorm over the Braunston Catchment and North Daventry substantial quantities of water entered the canal resulting in overtopping in the length of canal around Bridge 88. (See photograph 1). Water cascaded into the adjacent fields.

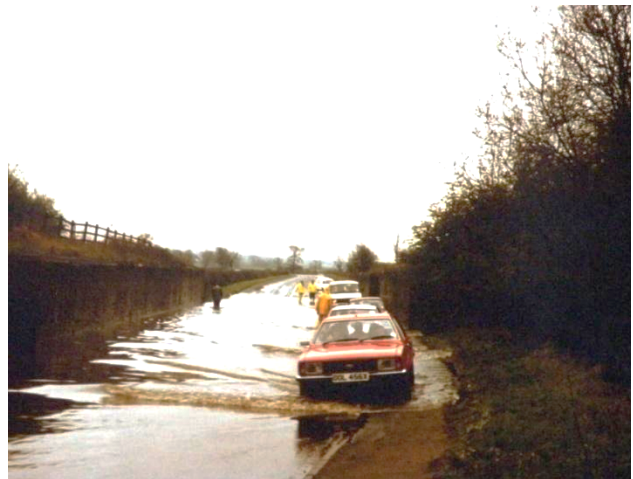
Photo 2:- A45 Flooded by Canal water off fields to East of Road (Old Station Bridge)

All the floodwater cannot pass through the two culverts and the surplus spreads across the adjacent fields. Because the A45 is higher than the surrounding fields the water accumulates and flows back towards the old Great Central Railway station. (The Turnpike was raised to avoid boggy ground when the

road was built in the 1700's). When the GCR was built the roadway below the bridge was lowered to provide extra clearance allowing the floodwater to build up on the roadway and flow diagonally across the road to bring floods into the village of Willoughby. (See photograph 2)

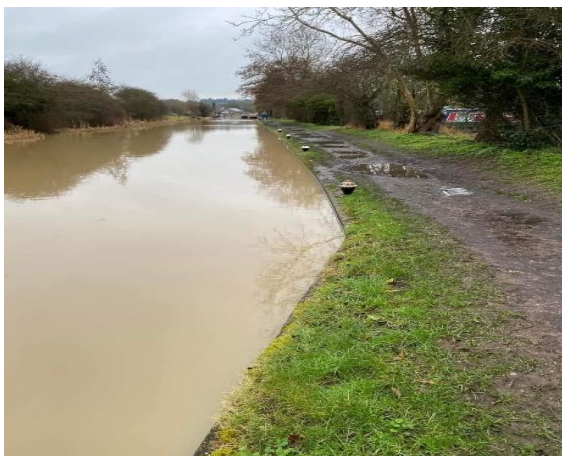
Photo 3 :- Oxford Canal topping banks towards Flecknoe

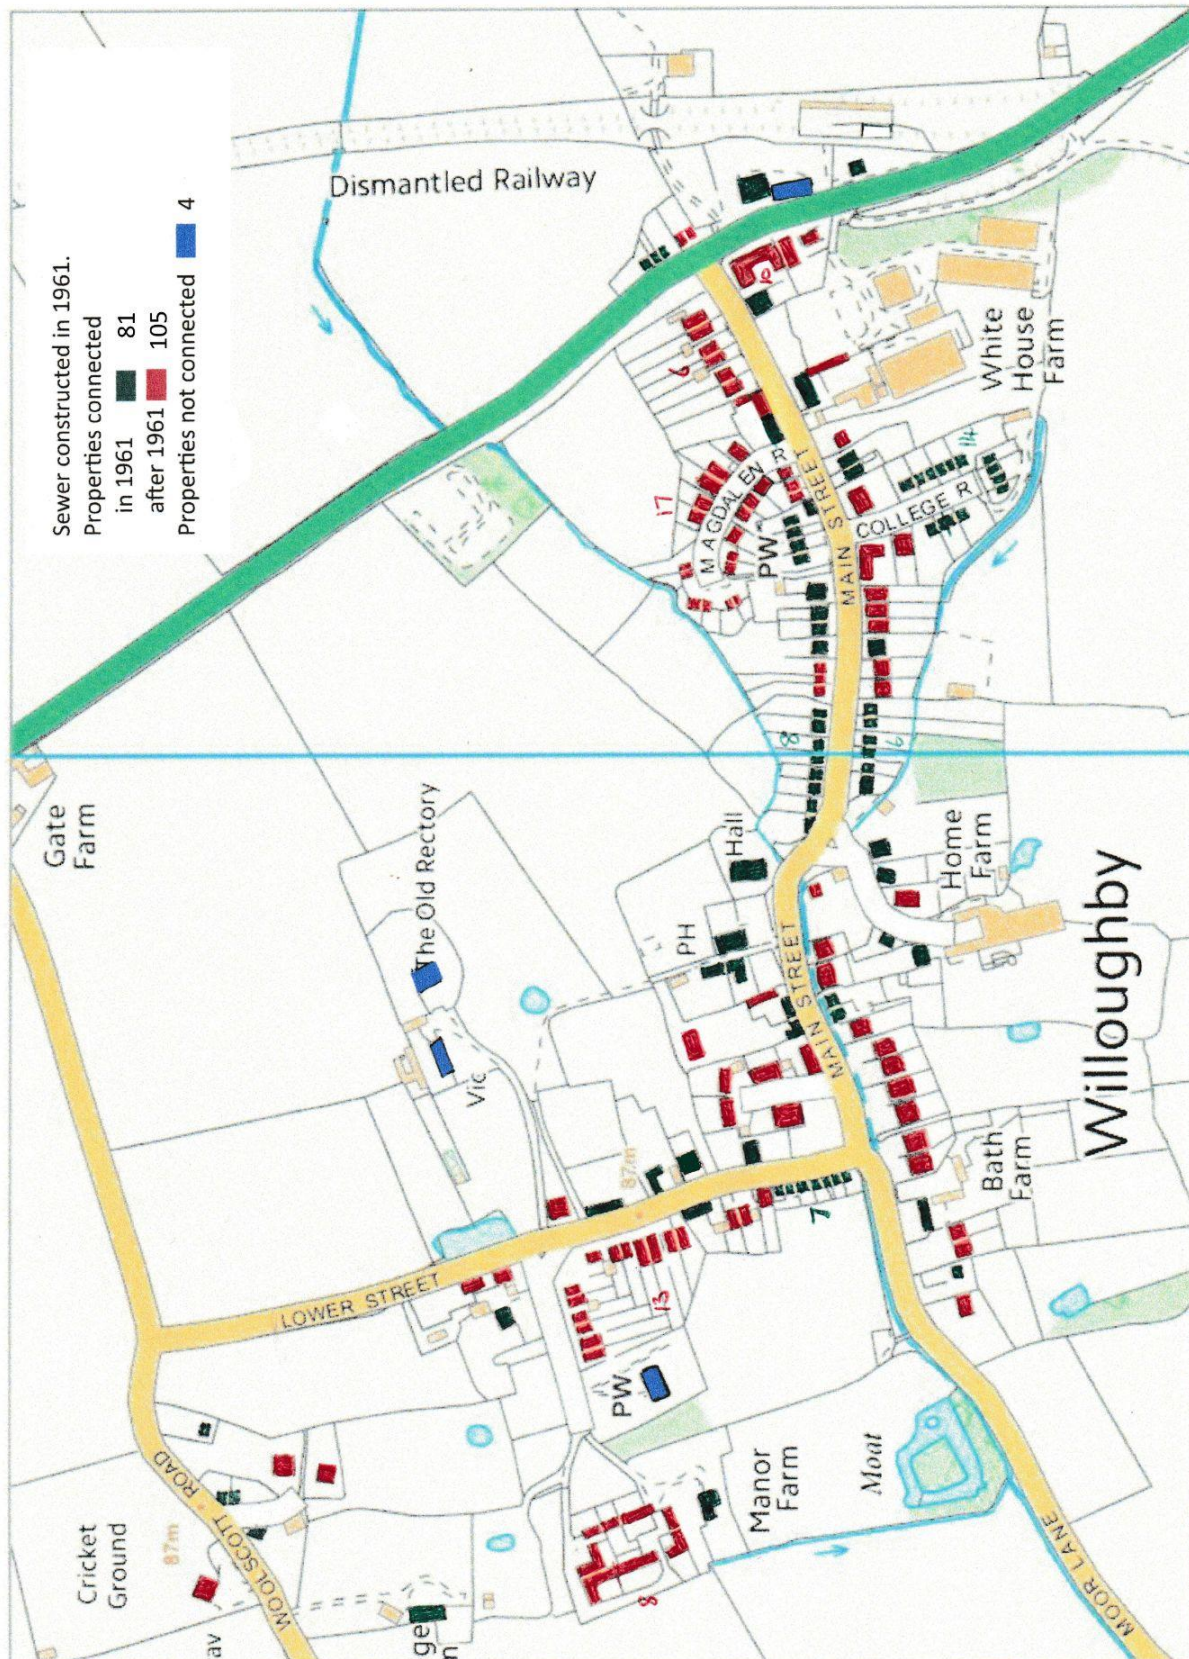
## Appendix B. Sewerage System - Properties built before and after 1961

The main sewer in the village was constructed in 1961. A plan has been produced showing the number of properties that existed in 1961 (81) and the number built afterwards (105). The sewer is a combined sewer into which most properties disgorge both sewage and rainwater. This leads to overloading of the sewer during periods of sustained rainfall and the lifting of inspection chamber covers so that sewage overflows into floodwater creating a significant environmental and health hazard.
