Safety Inspection Report

Annual Inspection

Playing Field

Willoughby Parish Council

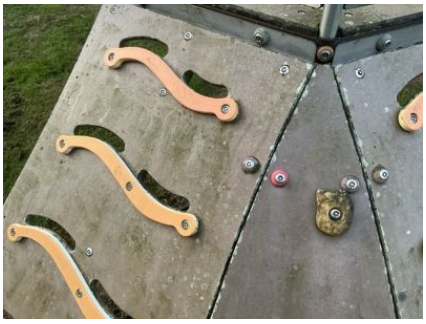
Multiplay - Slide Climber

The equipment is dirty or algae covered.

4

Clean off.
